Evaluating Corrosion of the Steel Liners of the Red Hill Tanks

Why Did Tank 5 Leak Approximately 27,000 Gallons of Jet Fuel In January 2014?

Tank Upgrade Alternatives

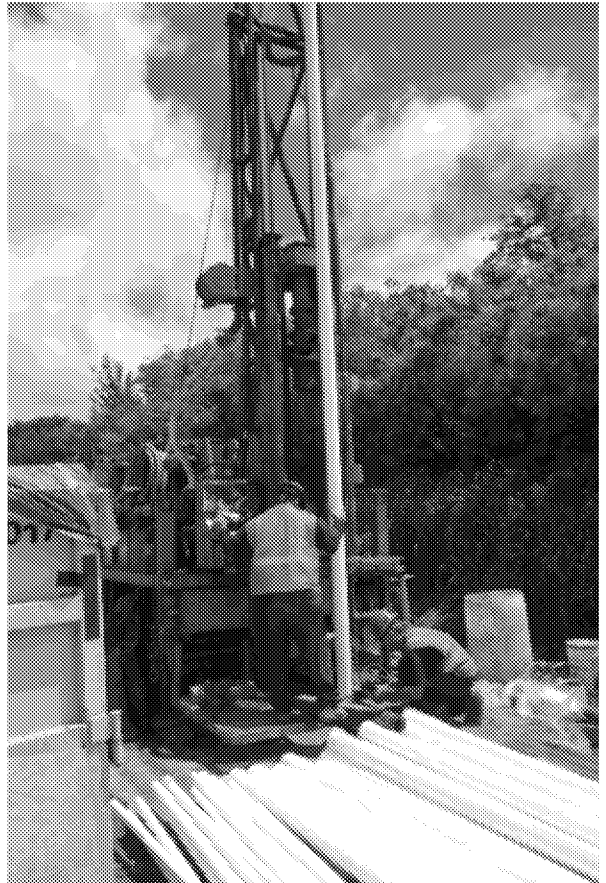
**Need to Understand
Dip and Strike to Pre-
dict NAPL Movement**

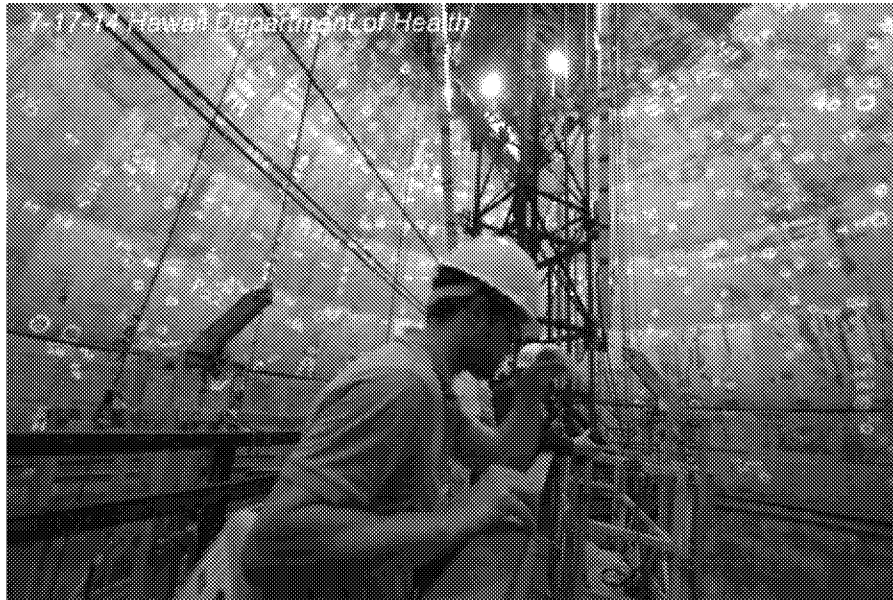
- Patch Plates Were Installed to Address Defects Identified by Non-Destructive Testing (Standard Petroleum Industry Practice)
- The Quality of the Repairs Including the Welds Were Not Verified by the Navy
- The Contractor Doing the Work on Tank 5 was a New Contractor for Red Hill
- Tank 5 Was Rapidly Filled When Taken Back Into Service

- New Repair Verification Procedures
- More Frequent Tank Tightness Testing
- New Procedures for Filling During Recommissioning After Repair
- New Alarm Response Procedures
- Improvements in Contractor Specifications

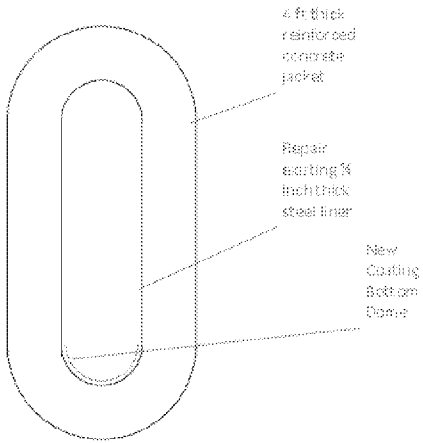
Alternate 1A

1A—Single Walled—Restoration of Tank

- ♦ Current approach to inspection and repair with enhanced TIRM
- ♦ Coating of lower dome

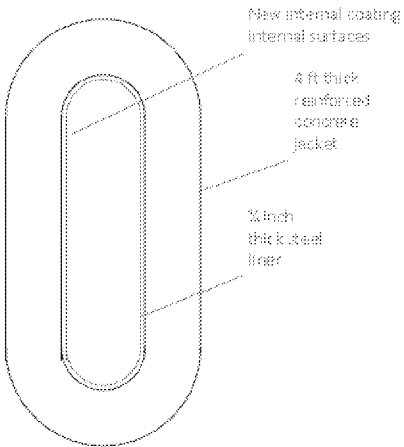
Alternate 1B

1B—Single Walled—Restoration of Tank Plus Interior Coating

- ♦ Same as Alternative 1A plus coating of barrel and upper dome

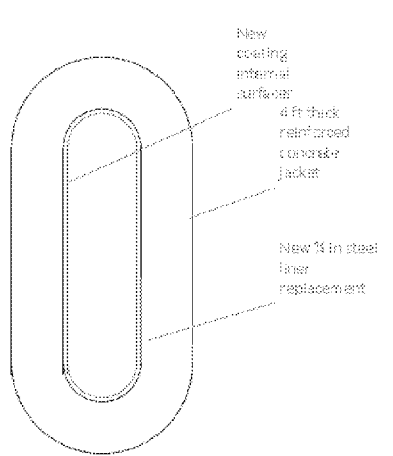
Alternate 1D

1D—Single Walled—Remove Steel Liner and Install New Steel Liner

- ♦ Remove existing steel liner in its entirety
- ♦ Provide new carbon steel liner

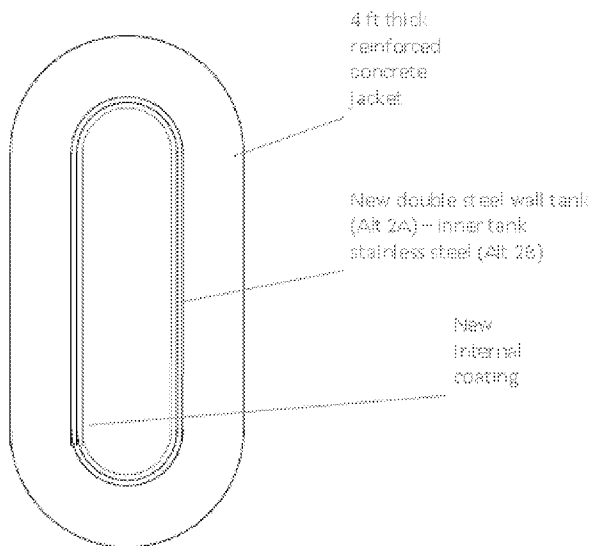
Alternate 2A/2B

2A—Double Walled—Composite Tank with Second Carbon Steel Liner

- ♦ Existing steel liner provides secondary containment
- ♦ Construct carbon steel liner with three inch interstitial space
- ♦ Internal coating of new steel liner

2B—Double Walled—Composite Tank with Stainless Steel Liner

- ♦ Same as 2A except new internal liner is stainless steel
- ♦ No internal coating
